## National Register of Historic Places Registration Form

historic name Stratton

other names QA-90; Hortense Fleckenstein Farm; Solomon Scott Farm

QA-90  
Stratton

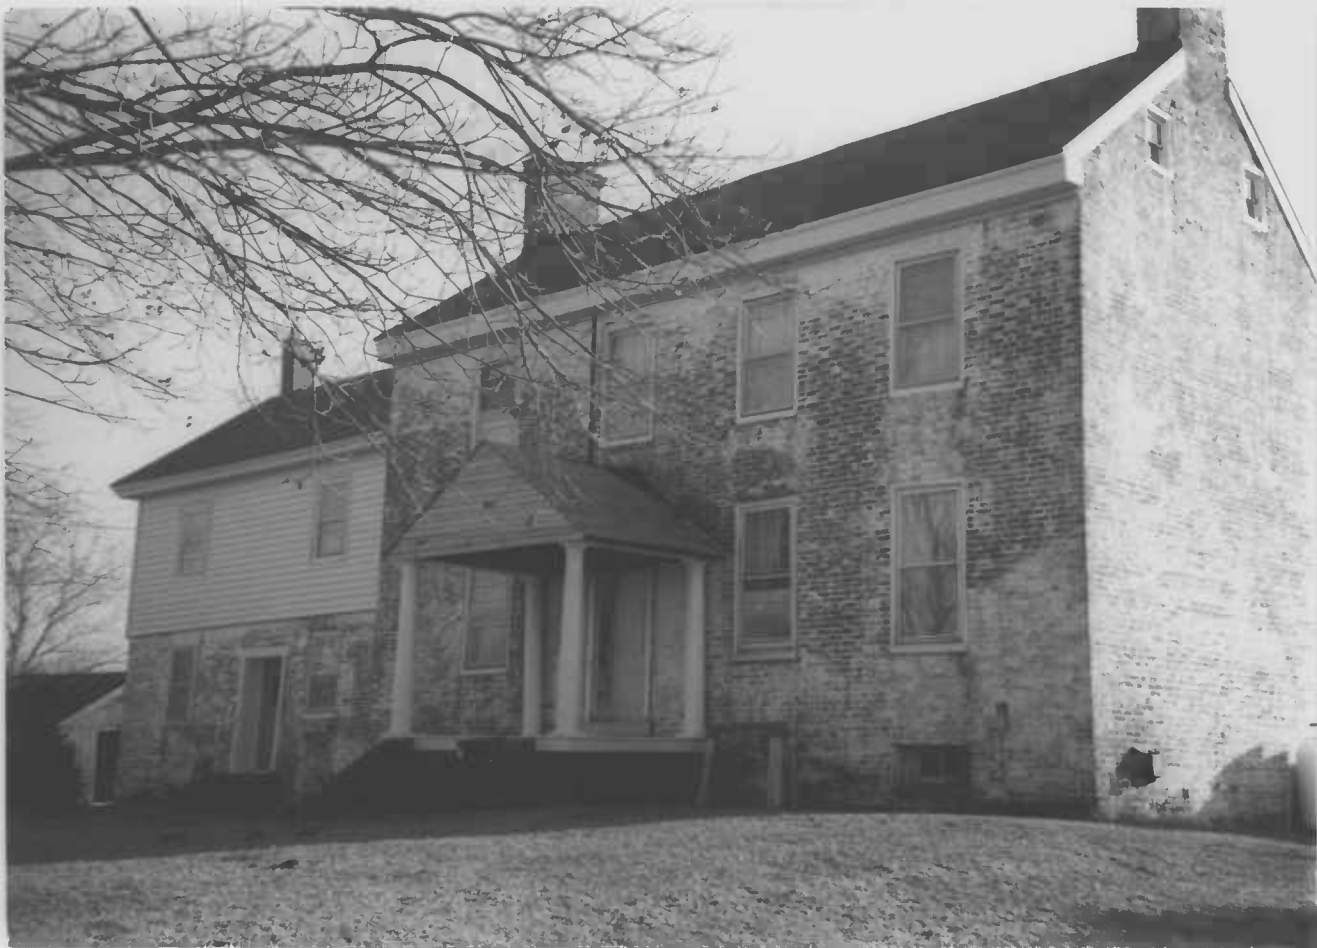
1 of 9

main facade

The front façade of Stratton faces north toward the road. The brickwork is laid in Flemish bond above a three-course bond foundation, with no water table or belt course. The door is offset to the left (east) of center with one 6/6 window to the left and two to the right. There are four smaller 6/6 windows on the second floor and two three-light cellar windows. The first floor 6/6 sash probably replaces original 9/6 sash. The original front door has been replaced by a four-panel door, but the original paneled jambs and exterior double architrave survive intact. The window openings on this façade have wood sills and no visible lintels on the first and second floors. The front door has a large granite sill. The cellar windows have rowlock lintels. The original cornice has been replaced with a simple box cornice; the roof is asphalt shingle.

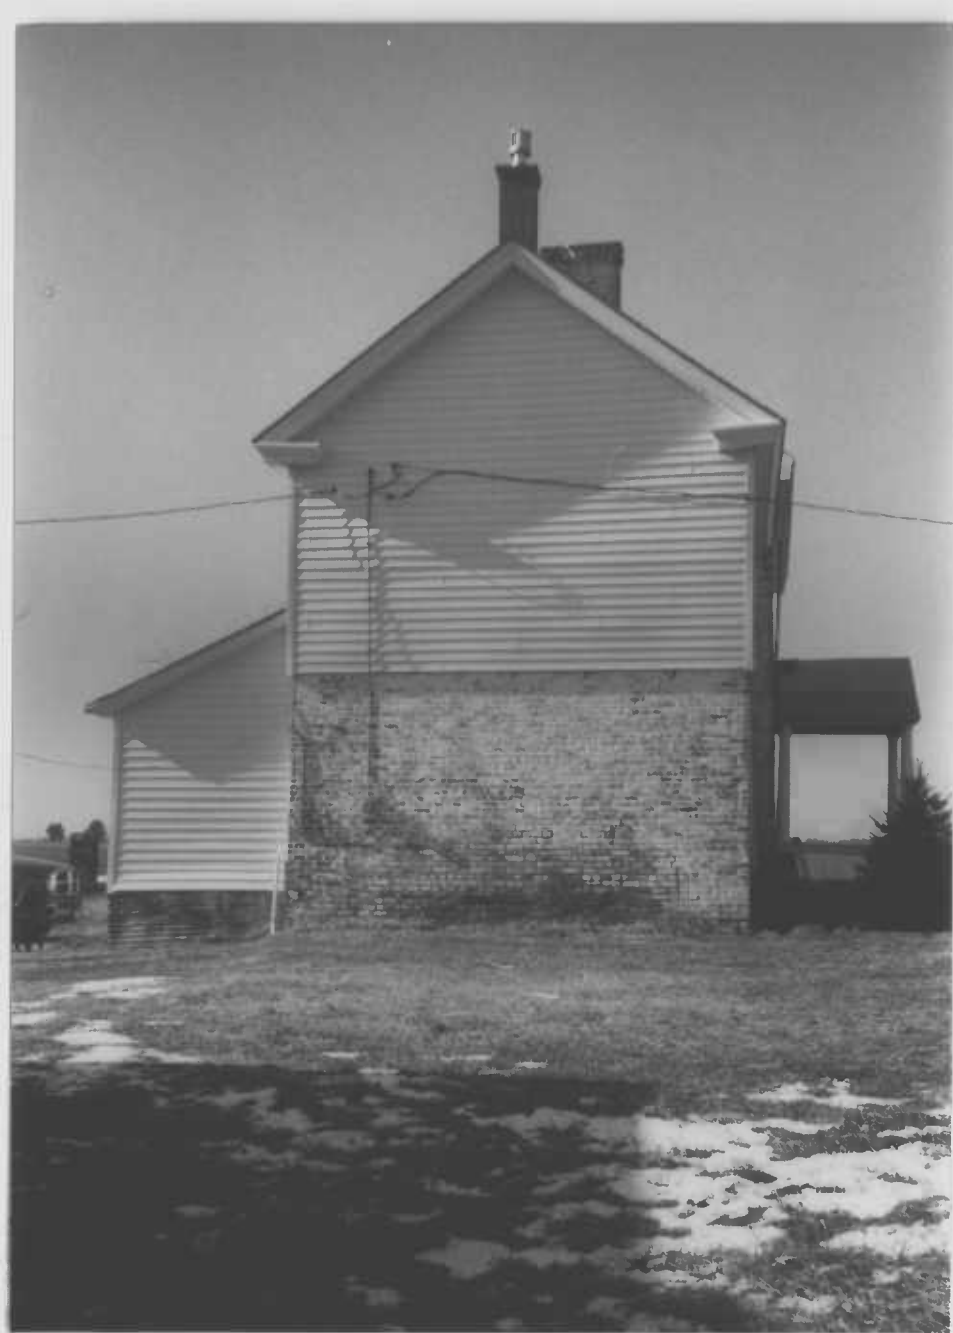
4 of 9

East facade

The majority of the east gable wall is concealed by the enlarged two-story wing. The paired 2/2 windows survive in the upper gable and several put-log holes remain visible. An early

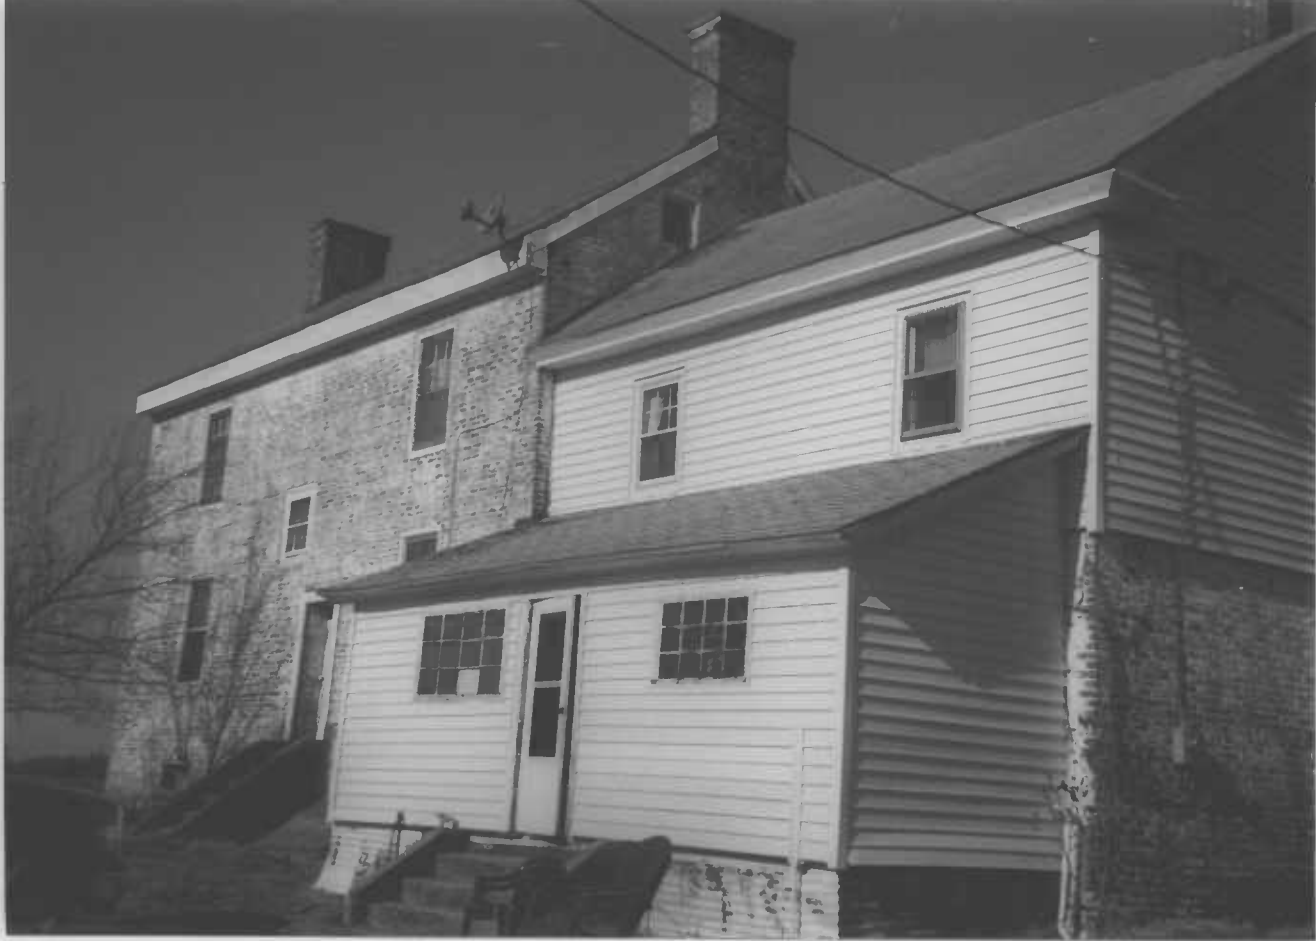
5 of 9

rear facade

The rear façade, facing south, is not symmetrical with the front façade. The rear door is offset to right of center with one large 6/6 window on each side. There are two 6/6 windows on the second floor, one directly above each first floor window, and one 3/6 window downset in the center bay. A three-light cellar window pierces the foundation in the west bay, balanced by a bulkhead cellar entrance in the east bay. The first floor sash probably replaces 9/6 sash, and it would appear that the overall height of each opening has been reduced by one brick course at the top. The small 3/6 window in the center bay appears to be set in an original, heavy pegged and beaded frame with an ovolo backband. All other frames appear replaced. The rear door and architrave have also been replaced, but the paneled jambs survive. It is interesting to note that the lintels on all but the 3/6 window are expressed on this façade by a single rowlock course. The box cornice is a replacement; the roof is asphalt shingle.

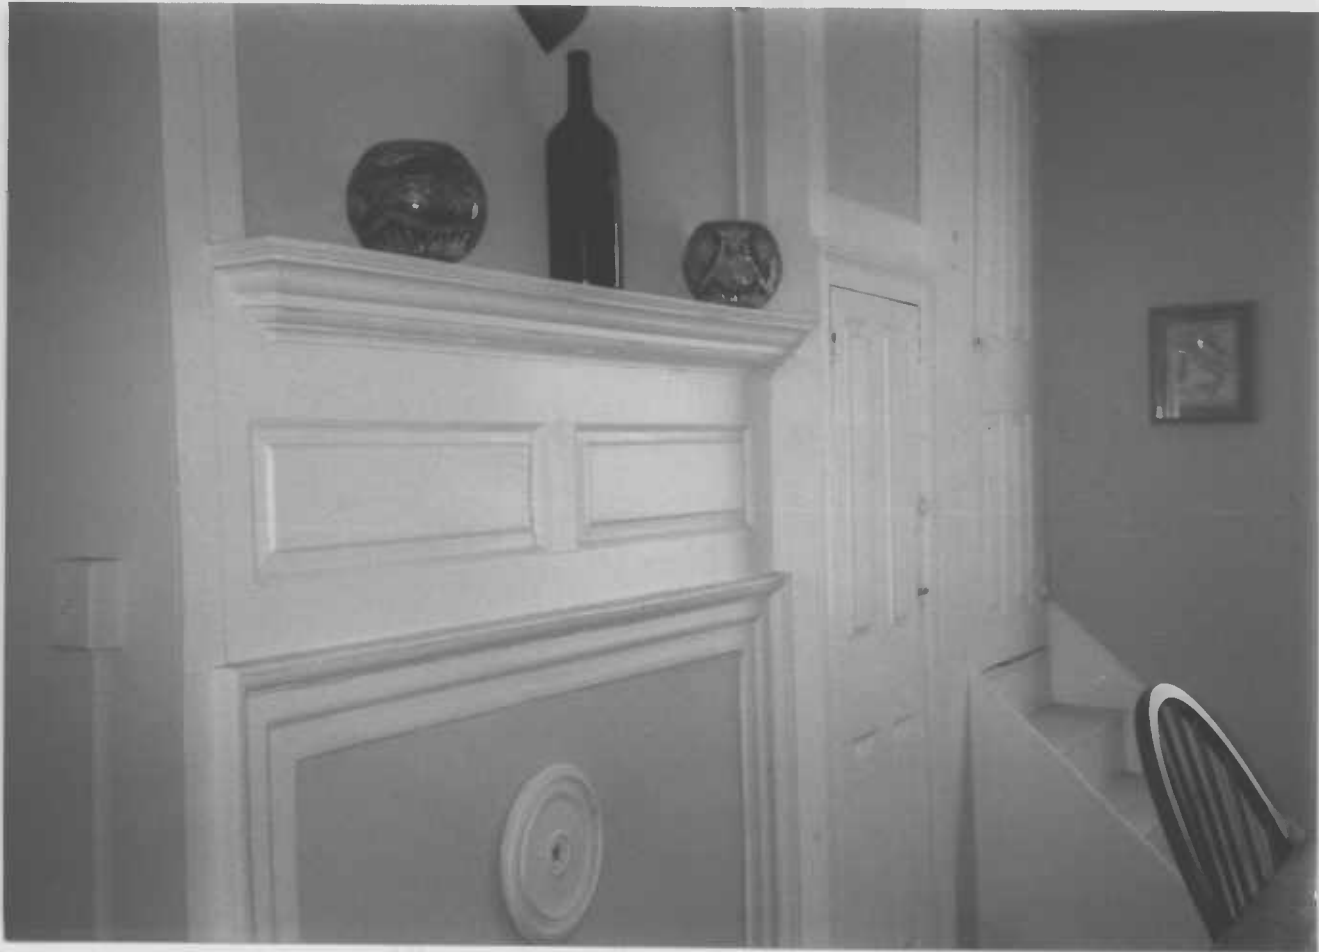
6 of 9

dining room

The east room most likely served as the dining room based on the original exterior door in the gable wall to the left of the fireplace, suggesting a kitchen building off the east end of the

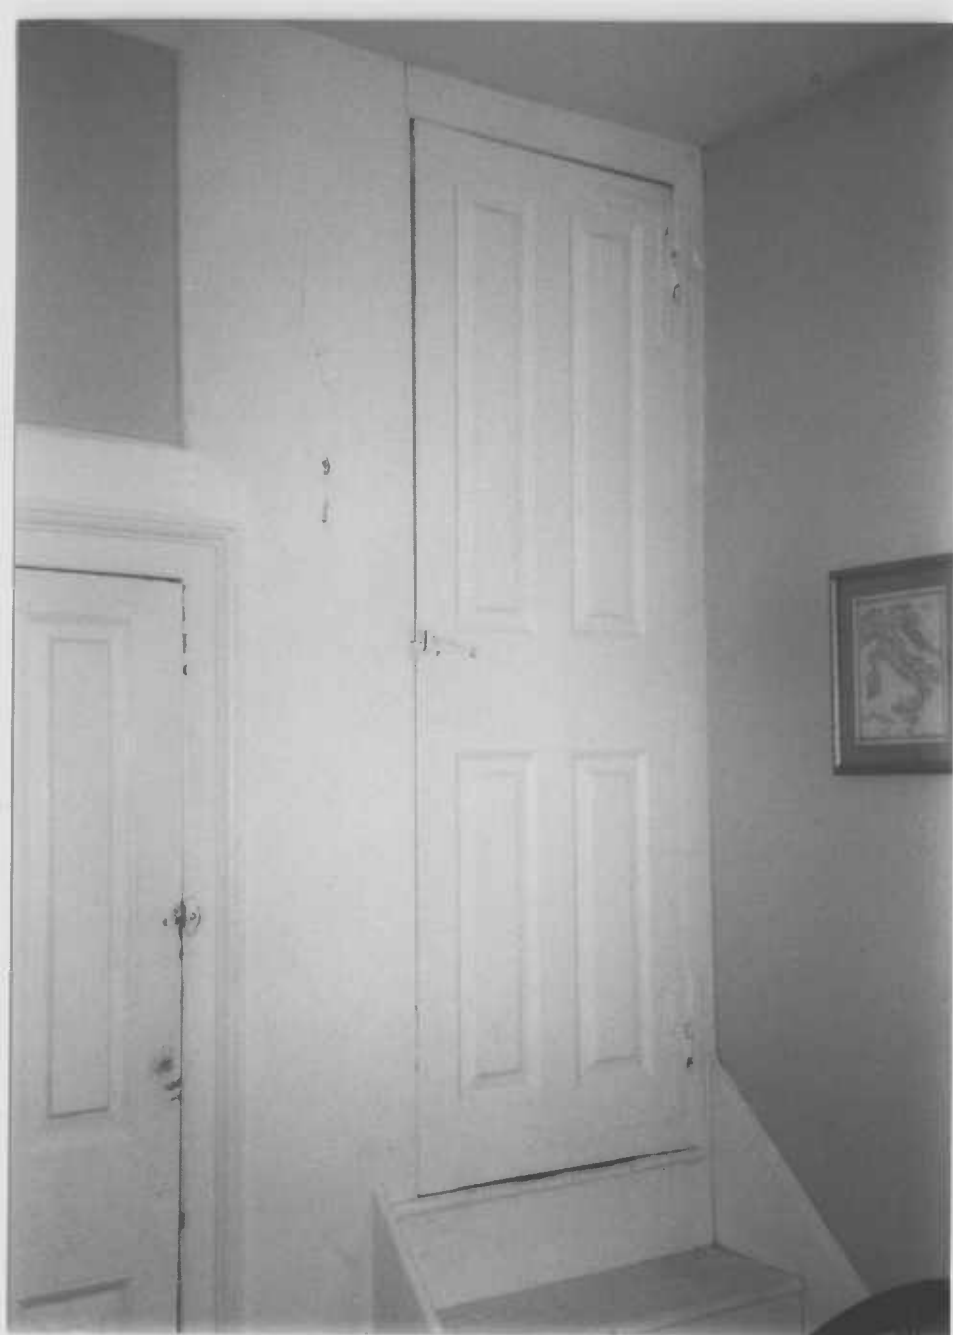
7 of 9

dining room east corner

house. The fireplace is on the east gable wall and projects into the room 1'9". The gable door is to the left; a winder stair and closet fill the space to the right of the chimney. The fireplace has been blocked and the hearth has been covered when narrow tongue-and-groove flooring was installed on top of the original flooring in the 20<sup>th</sup> century. (Original flooring is visible in the closet and from the cellar below.) The fireplace is framed with a double architrave topped by two raised panels and a complex molded shelf. Beaded styles and rails frame a rectangular panel above the shelf that may have been a raised or plaster-finished panel. A scar indicates a stove flue was cut through this panel at a later date. The stair rises four steps with a simple closed string carriage to a door, then winds 90 degrees and rises to a second 90-degree winder that leads into the east chamber of the second floor. The door to the stair has four panels, fully raised and molded, and hangs on hand-wrought H-L hinges; it retains the original wrought iron latch and handle. The 4-panel closet door matches that to the stair but now hangs on three-inch, five-knuckle butt hinges. Paint ghosts indicate early H-L hinges, and keyhole scars survive from two generations of rimlocks. The door is now fastened solely by a small wooden turn latch; wear from the latch reveals early green paint. Single windows are centered on the front and rear walls. Window and door architraves are single rather than double and are trimmed with ovolo backbands. Architraves are not crossetted. The door to the passage has been removed but remains stored in the cellar.

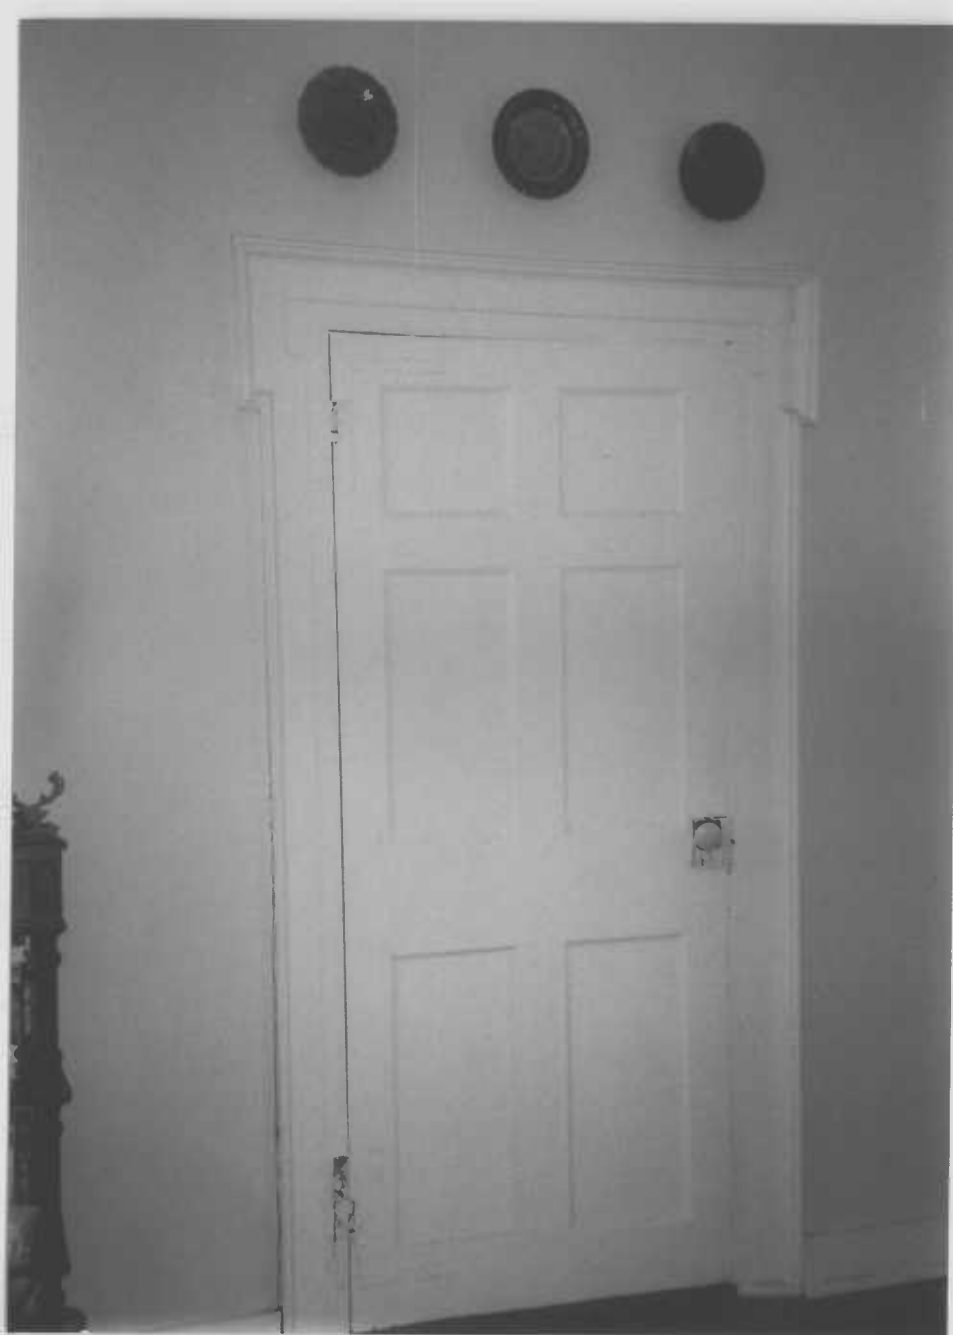
8 of 9

west parlor door

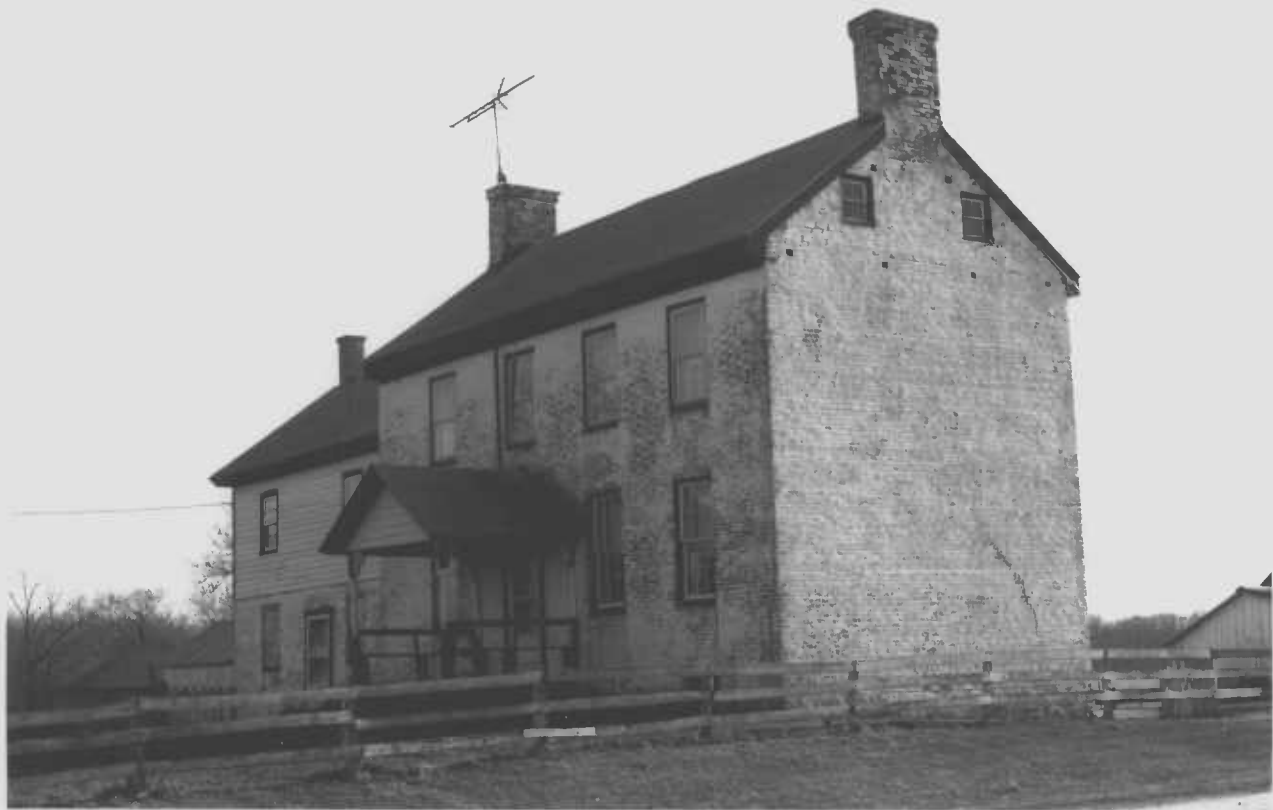
QA-90  
Hortense Fleckinstein Farm  
Ruthsburg vicinity  
Orlando Ridout V Dec. 1980  
View from Northwest
